# AMP7 Bathing Water Ambition Investigations Programme

## Mothecombe

## Executive Summary

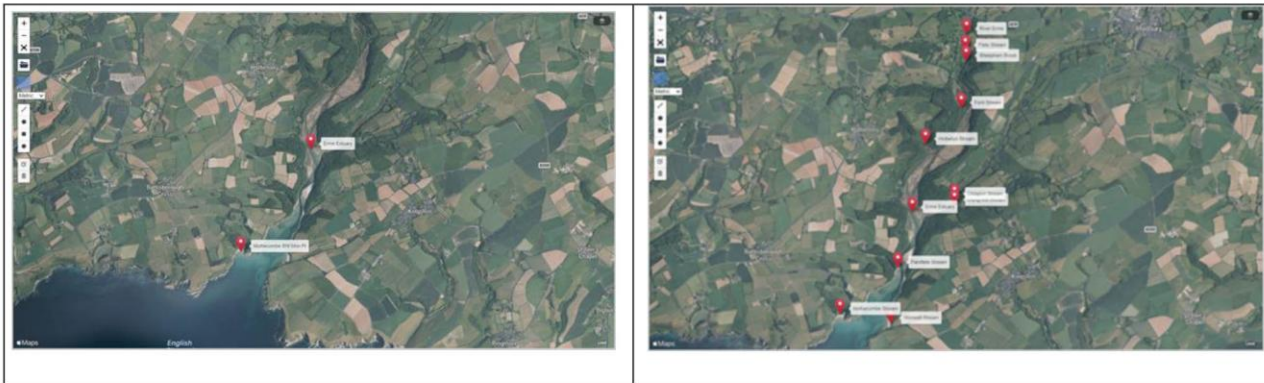
**Figure 1:** Mothecombe Bathing Water at the mouth of the Erme Estuary

Mothecombe Bathing Water is a small sandy beach at the mouth of the Erme Estuary on the south Devon coast. The main freshwater input to the Erme Estuary is the River Erme, while there are nine other streams which flow into the Estuary. Oceanographic studies and salinity analysis demonstrate the importance of freshwater inputs on the bathing water quality at Mothecombe. Local freshwater inputs include the Mothecombe Stream and Wonwell Stream and the other freshwater inputs up the Erme Estuary. It was determined that the River Erme is the most significant freshwater input in terms of flow, followed by the Sheephams Brook. There are four sewage treatment works (STW) in the Mothecombe catchment, these are Ermington STW, Holbeton STW, Ivybridge STW and Modbury STW which all discharge to the Erme or associated tributaries. The final effluent from Holbeton STW, Ivybridge STW received ultraviolet (UV) disinfection. There are several intermittent discharges further upstream to the Erme estuary and its respective streams. These include Storm Overflows (SO) from the STWs (e.g. Modbury STW SSO and Holbeton STW SSO) and combined sewer overflows (CSO) (e.g. Poundwell Meadow CSO).
